## **ENGINEERING ASSESSMENT FOR LINE 9 REVERSAL PHASE 1**

NATIONAL ENERGY BOARD

Enbridge Pipelines Inc. Pipeline Integrity Department

AUGUST 2011

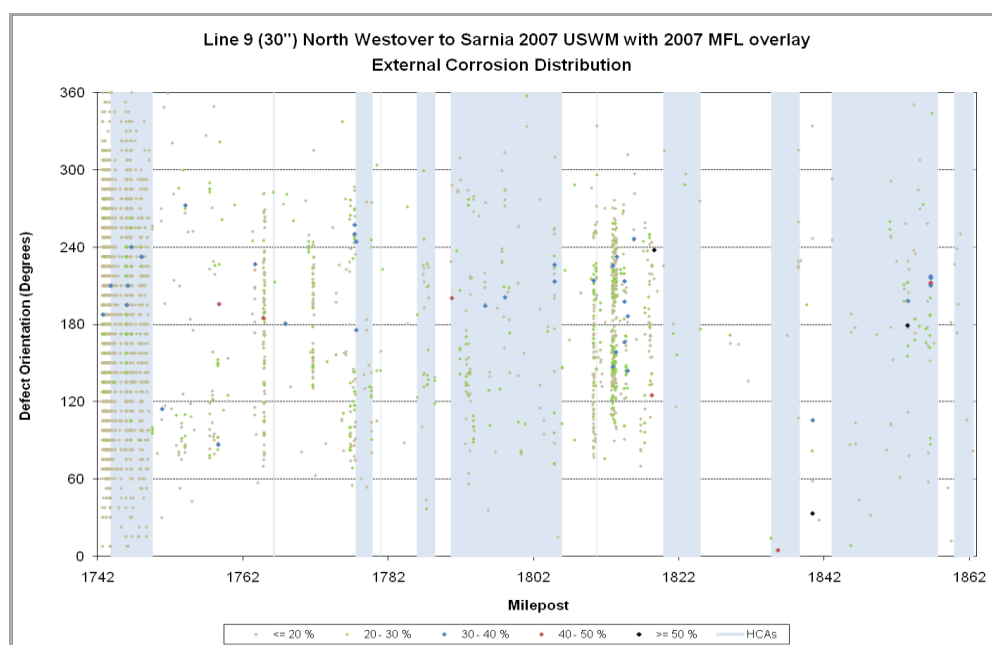
Figure 4.1 - Distribution of External Metal Loss

Metal loss depth severity is plotted as circumferential orientation versus their axial location. Figures 4.1 and 4.2 describe the external and internal corrosion feature distributions respectively. The metal loss severity, taken from the overlaid 2007 Ultrasound Wall Metal ("USWM") and MFL data, has been delineated by the use of different colours as identified in the chart legends. The bands of external corrosion all occurred at areas of significant elevation change, while there are no apparent trends of internal corrosion along the pipeline suggesting the internal mitigation program is adequate.

As can be seen in Figures 4.1 through 4.3 the majority of the metal loss anomalies detected have a low depth severity and do not pose a threat to the integrity of the pipeline. Four features identified in Figure 4.3, with greater than or equal to 50% depth, were excavated and two required a sleeve repair while the other two only required a recoat.

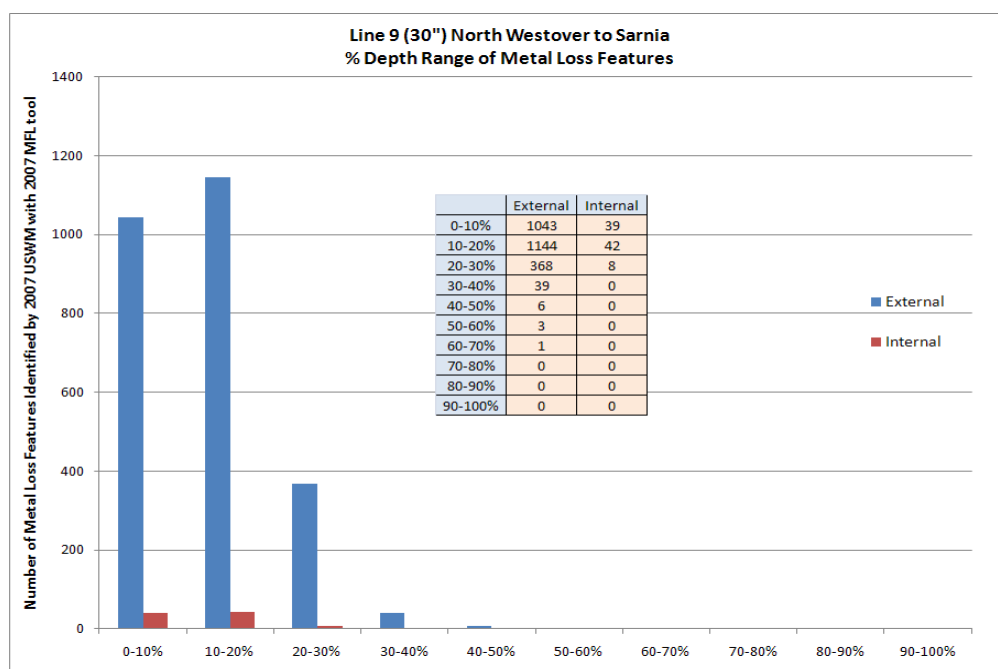
Figure 4.3 – Percent Depth Range of Metal Loss

Figure 4.3 shows number of metal loss ILI anomalies grouped into depth ranges of 10%.

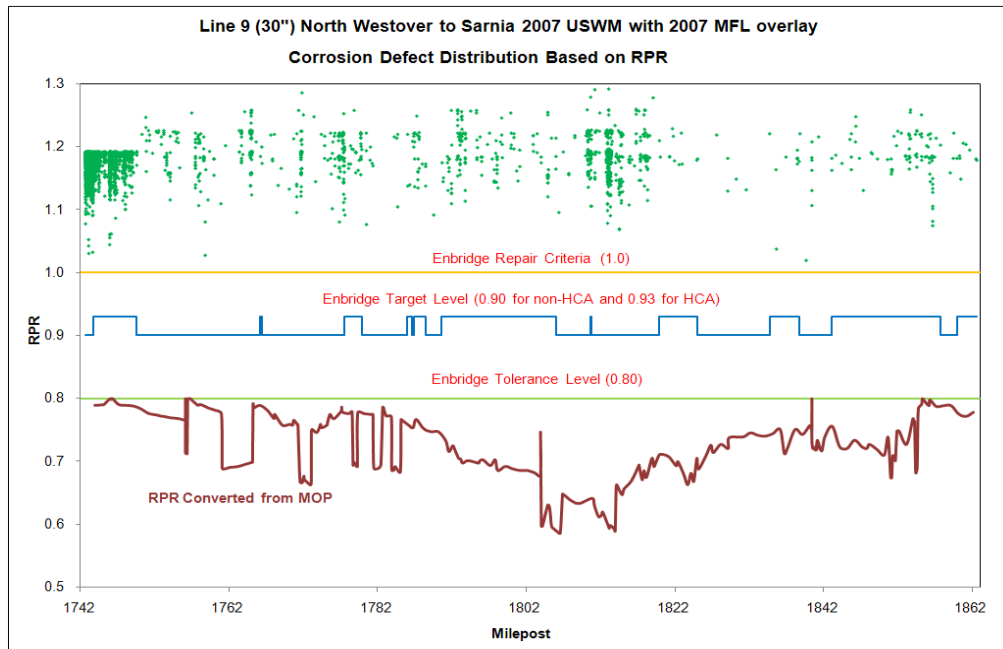
Figure 4.4 – Line 9 (NW – SA) – Predicted Metal Loss Failure Pressure

Metal loss anomalies with ILI tool reported RPR values have been plotted by MP in Figure 4.4. Features are excavated, assessed and repaired when their predicted failure pressure falls to, or below, 1.0 RPR criteria or 100% of the SMYS. As can be seen from Figure 4.4 below, there are no metal loss features requiring excavation based on the 1.0-RPR criteria.

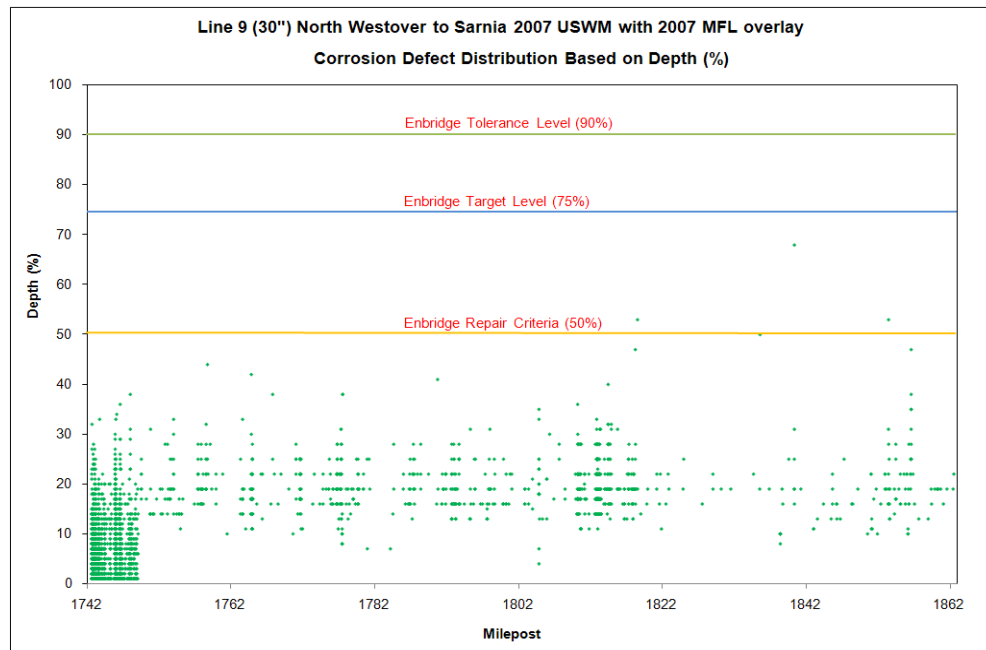
Figure 4.5 - Line 9 (NW – SA) – Metal Loss Depth Distribution

The depths of all metal loss anomalies identified by the 2007 ILI runs are plotted in Figure 4.5 along with the Enbridge standard excavation criteria, target level and tolerance level.

Features are excavated, assessed and repaired when their % depth rises to, or above, 50%. The four features that met the criteria in Figure 4.5 above were excavated and repaired.

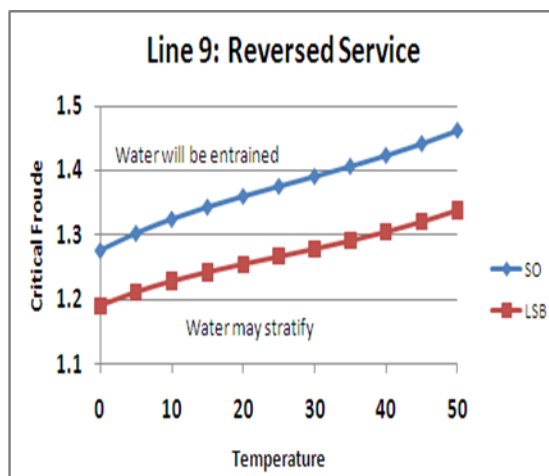
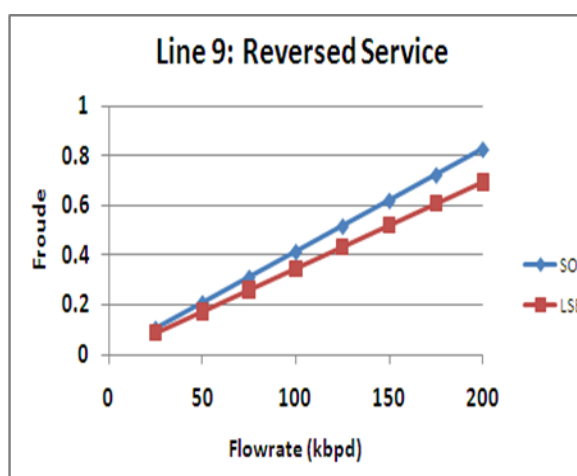
As shown in Figures 4.6 and 4.7, proposed lower annual rates are not expected to achieve the critical Froude number at which free water will be entrained in the light or sour crude oils. As such, a prevention program has been planned to displace corrodents on a regular basis through routine maintenance (cleaning) pigging.

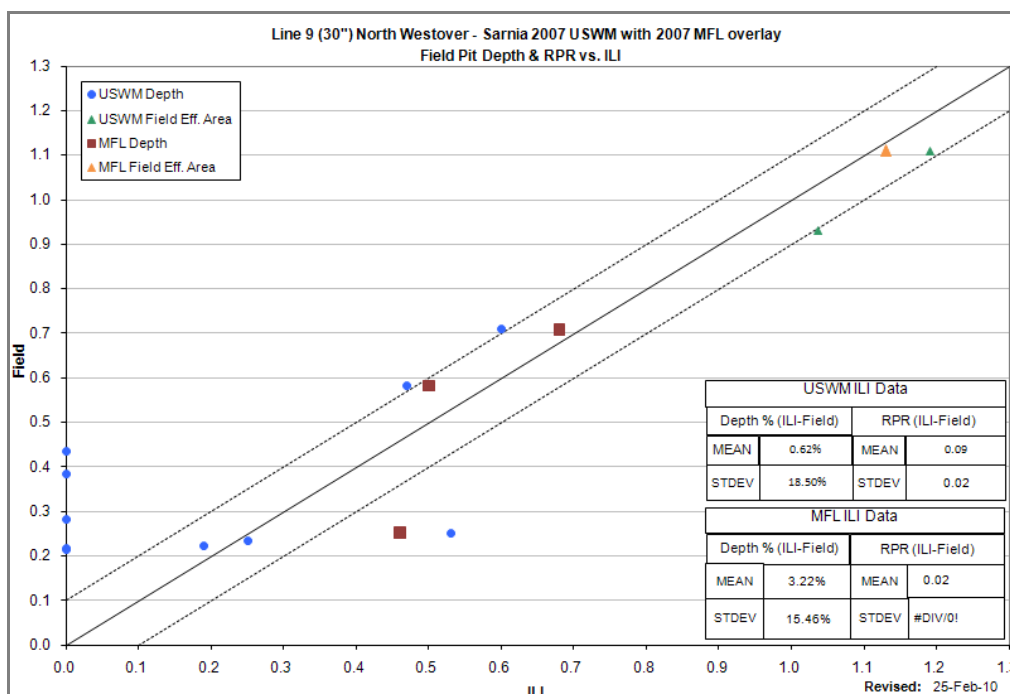
Figure 4.9 –Unity Plot: Line 9 (NW – SA)

The dig and repair program based on the 2007 metal loss inspection has been completed. The data and field verification results evaluated to date have been incorporated into this line's unity plot as shown in Figure 4.9.

It should be noted that the 2007 inspection program incorporated results from two different inspection technologies; USWM and MFL. The MFL inspection was performed to offset the limitations of UT inspection technology in detecting small diameter corrosion pits and as such, the vendor was only requested to report on deep pitting (>40% through wall). The limitation of the UT technology to see small diameter corrosion pits can be seen by the number of false negatives on the y-axis of the unity plot.

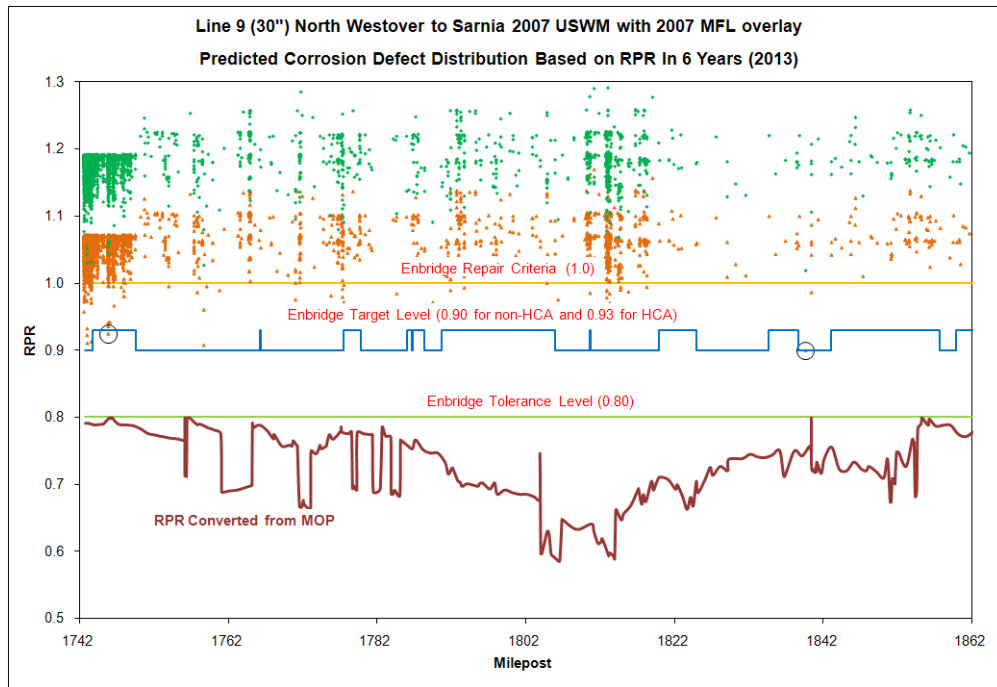
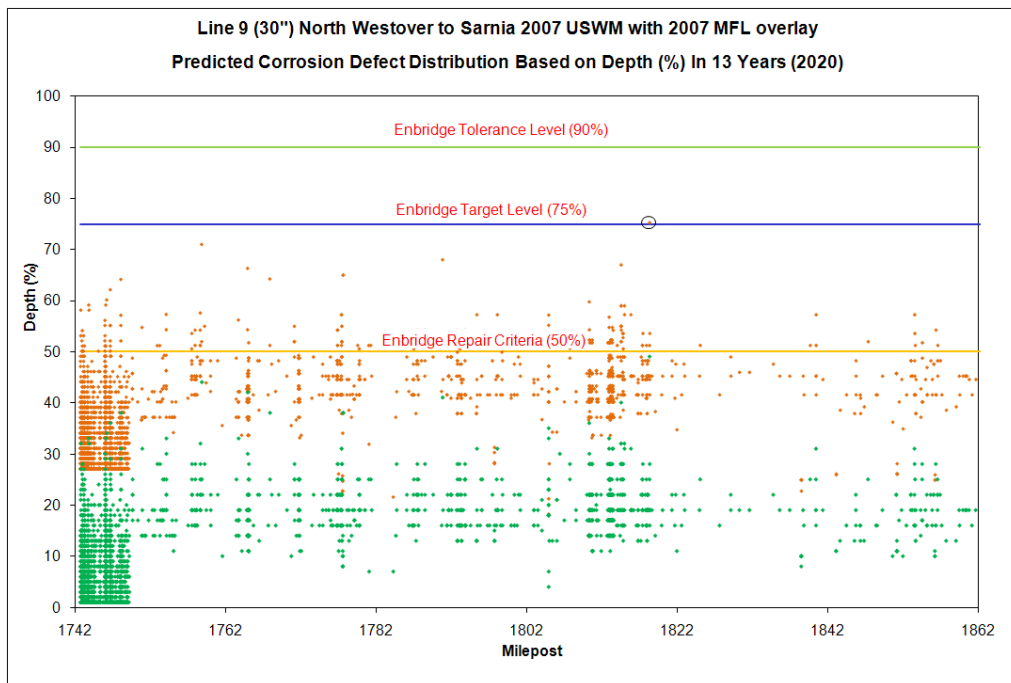
Figures 4.10 and 4.11 investigate the growth of general corrosion features (i.e. RPR values) and the depth of metal loss features over time based on the 2007 USWM ILI result.

The deterministic analysis, as summarized in Table 4.9, presents an RPR reassessment interval of 6 years and depth reassessment interval of 13 years. These generally large reassessment

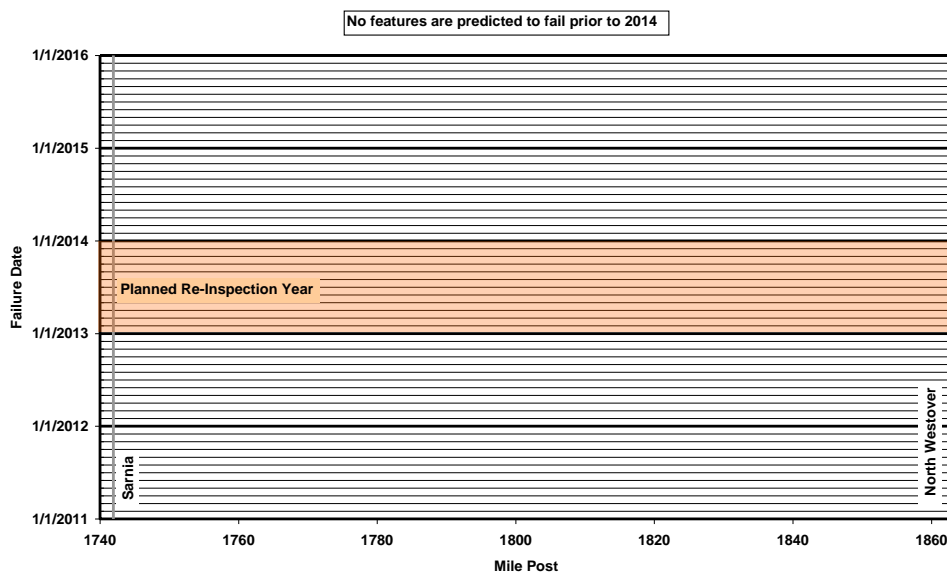
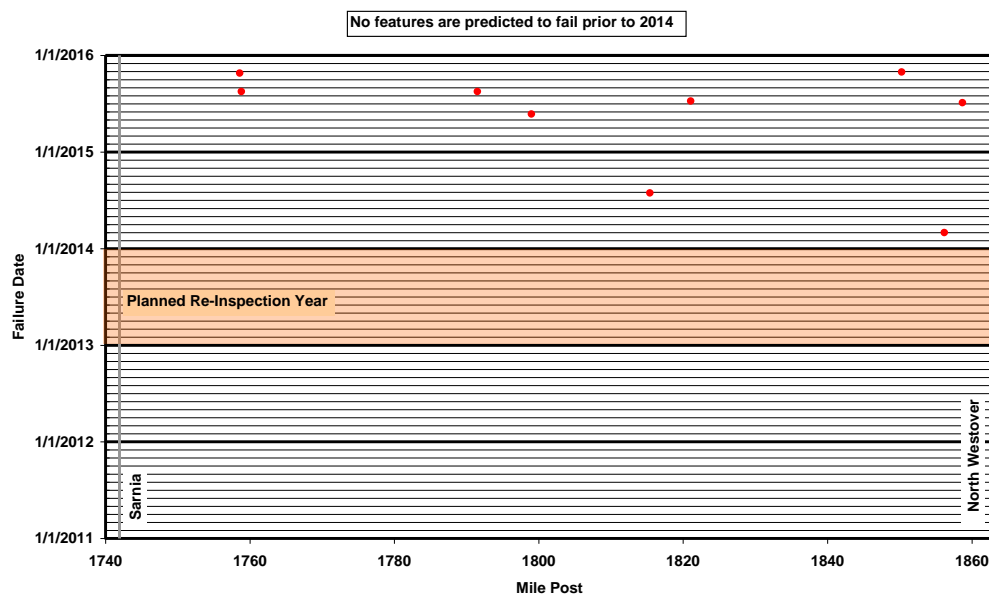
Based on the analysis discussed above, there are no adjusted tool reported features expected to fail at either the pre-flow reversal pressure (350 psi) or the post-pressure reversal pressure (492 psi) during the next 3 years (refer to Figures 4.23 and 4.24). Enbridge presently plans to re-inspect this portion of Line 9 in 2 years time.

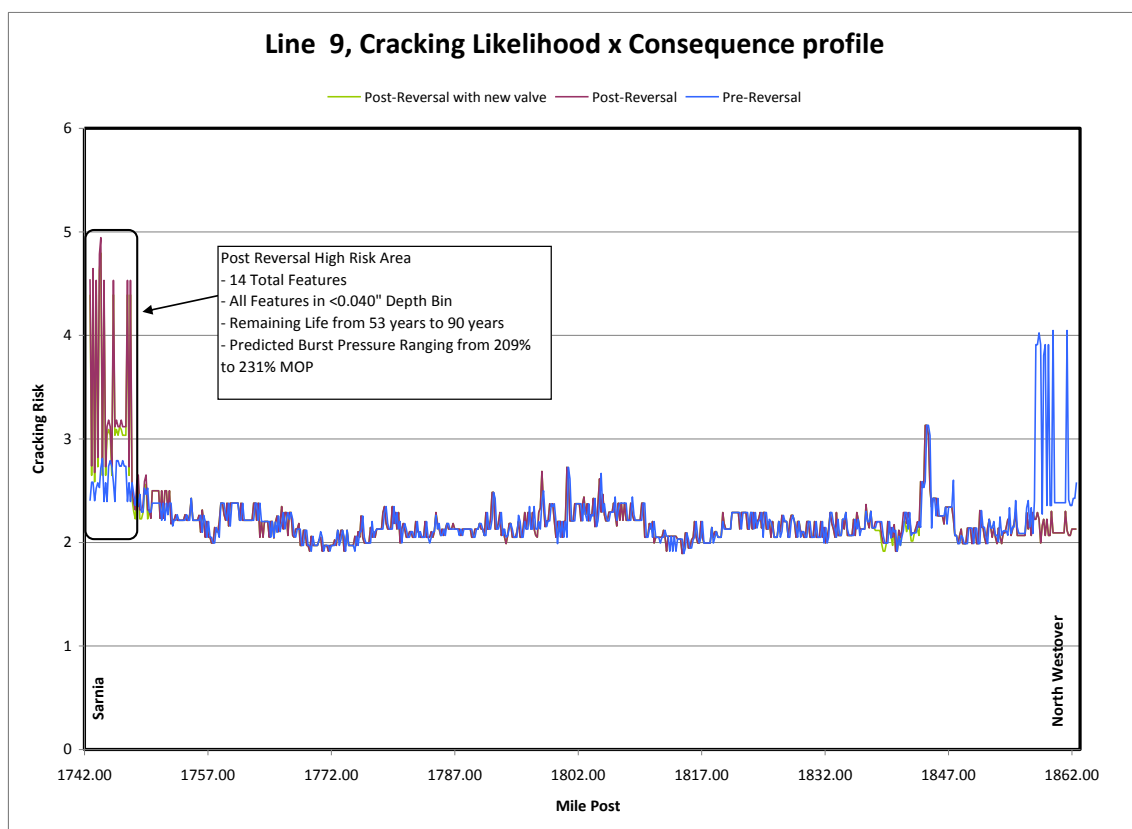
Figure 4.25 - Risk Assessment of Line 9 between SA and NW

Thus although the cracking risk profile is theoretically higher post-flow reversal immediately downstream of SA the 2008 crack detection data and subsequent EA would suggest that this section of line is not at an immediate threat from cracking related mechanisms.

Notwithstanding, investigative crack excavations will be conducted in 2012 on crack ILI reported defects with particular focus on the area west of SA.

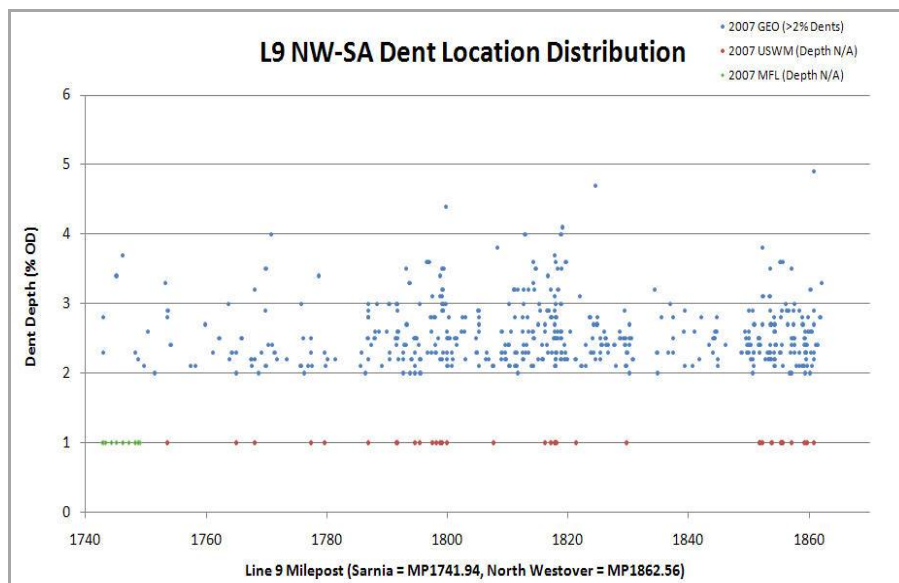
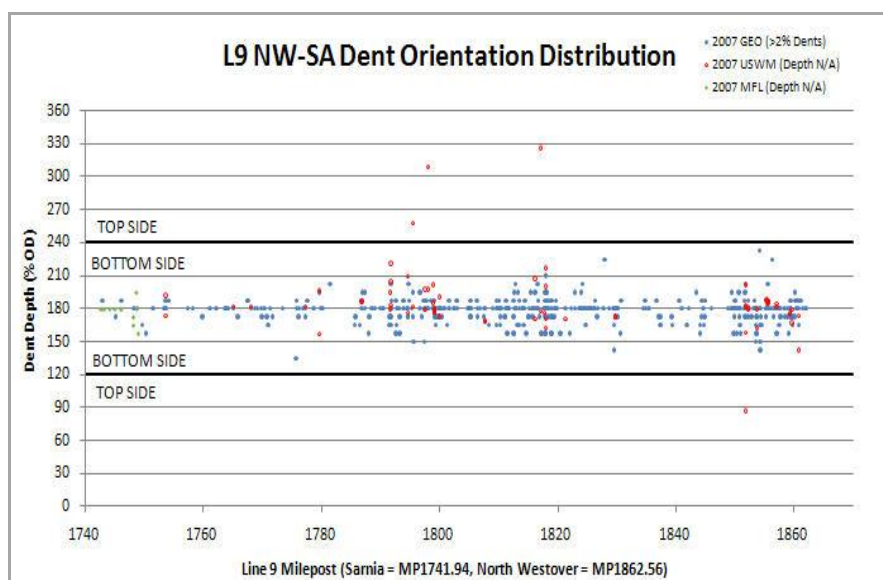
Based on the 2007 ILI reports, a total of 21 features were identified as meeting field assessment criteria and issued for excavation. Twenty (20) were identified as dents >2% interacting with girth welds and one (1) feature identified for excavation was reported in the USWM ILI report with the comment “geometry multiple” indicating a feature containing multiple apexes.
