## **PIPELINE INVESTIGATION REPORT**

**P01H0049**

### **CRUDE OIL PIPELINE RUPTURE**

**508-MILLIMETRE LINE 10, MILE POST 1885.64**

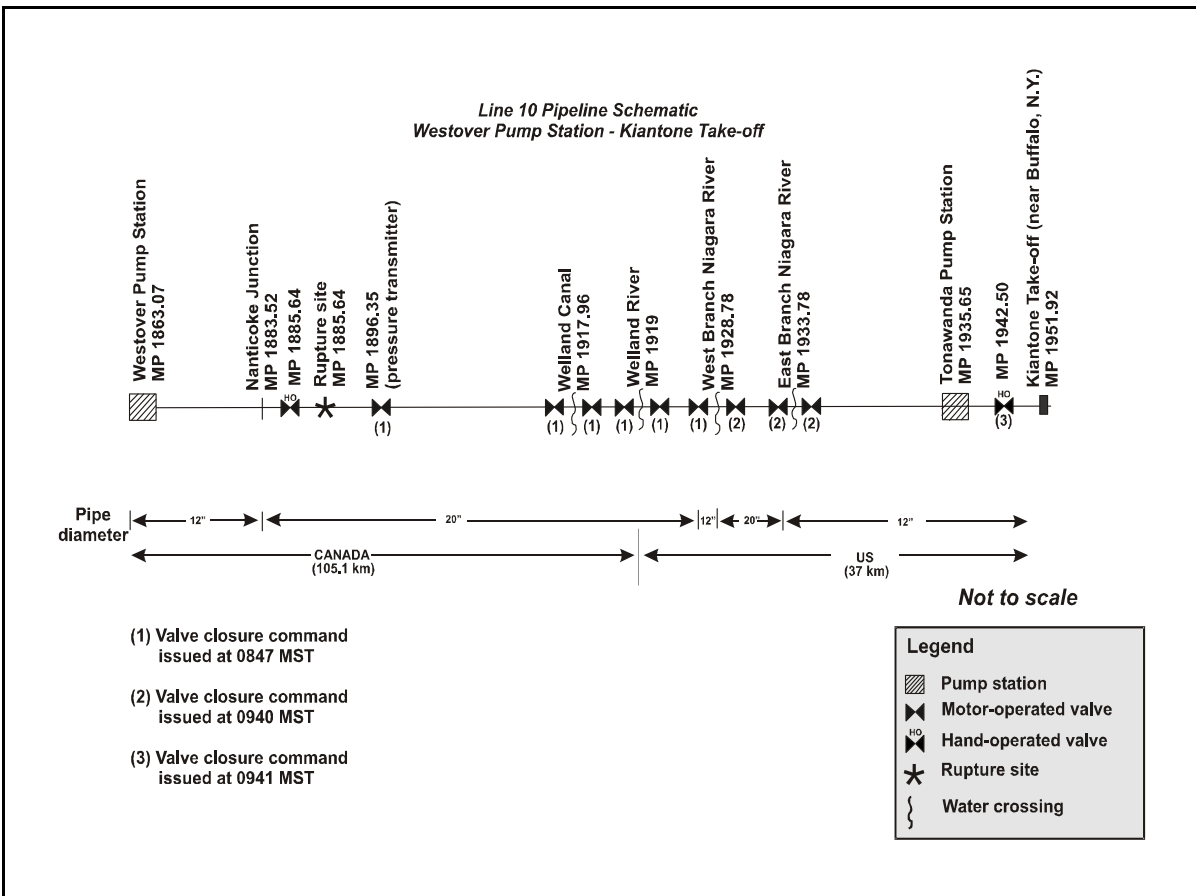
## Appendix A – Line 10 Pipeline Schematic

At 0836, the CCO noticed a pressure drop at the pressure transmitter at mile post (MP) 1896, 17 kilometres (km) downstream of the rupture location. Within eight minutes of the failure, the CCO had issued “stop” commands to the pump units at the Westover Pump Station (Westover) and Tonawanda, the stations upstream and downstream, respectively, of MP 1896, and had begun sectionalizing the line between those stations. At 0854, the CCO noticed that the sectionalizing valve at MP 1896 was stuck in travel and requested that the on-call maintenance person check the status of that valve. The on-call maintenance person investigated the pressure abnormalities at Westover and closed hand-operated valves, beginning at Westover. At 1003, the Westover area supervisor located the rupture at MP 1885.64 and took measures to secure the site. The on-call maintenance person was asked to assist with securing the failure site before continuing on to MP 1896. The valve at MP 1896 was handcranked closed at 1117. MP 1896 and locations further downstream are generally at lower elevations than the rupture site, which allowed some draining of the line fill while the valve at MP 1896 remained open. Appendix A shows a schematic of Line 10.
