## **ENGINEERING ASSESSMENT FOR LINE 9 REVERSAL PHASE 1**

NATIONAL ENERGY BOARD

Enbridge Pipelines Inc. Pipeline Integrity Department

AUGUST 2011

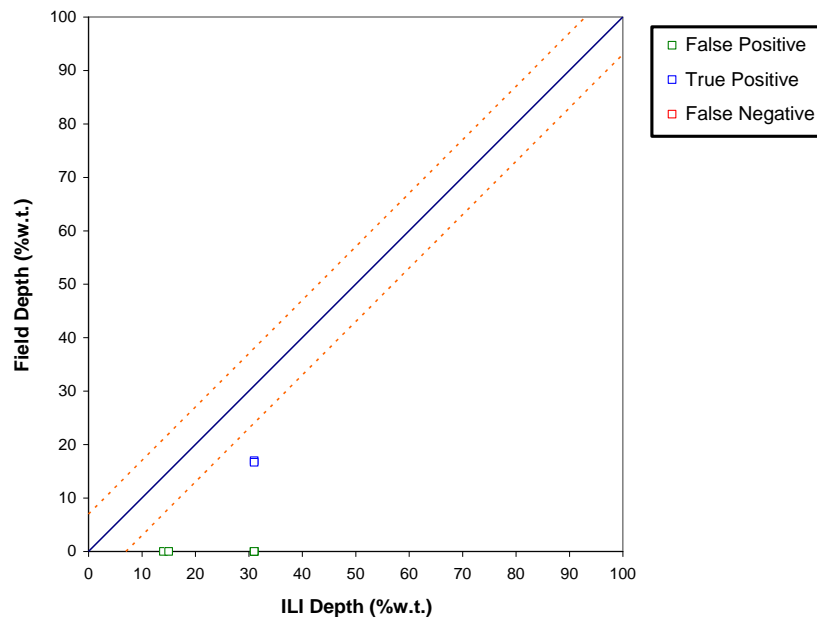
Figure 4.16 - Depth Unity Plot based on USCD 2008

The deepest field measurement of the 2 tool reported features was 1.4 mm (21% of the pipe wall thickness) which is within the tool reported depth range of 1 to 2 mm (15 to 31% of the pipe wall thickness). Figure 4.16 provides a graphical depiction of the depth based field-tool trending.

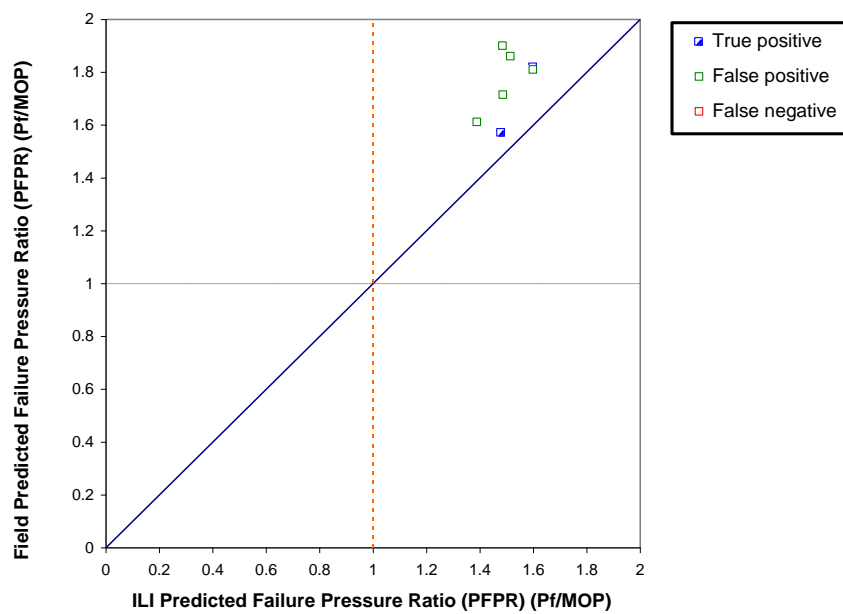
Figure 4.17. Fitness-for-Purpose Unity Plot based on USCD 2008

The lowest field predicted burst of the 2 tool reported features was 1020 psi (157% of the maximum allowable operating pressure ("MAOP") and 207% of the proposed normal operating pressure post reversal (492 psi) which is significantly greater than the tool predicted burst pressure of 814 psi (125% of the MAOP and 165% of the planned maximum discharge pressure (492 psi). Figure 4.17 provides a graphical depiction of the predicted burst pressure based field-tool trending.

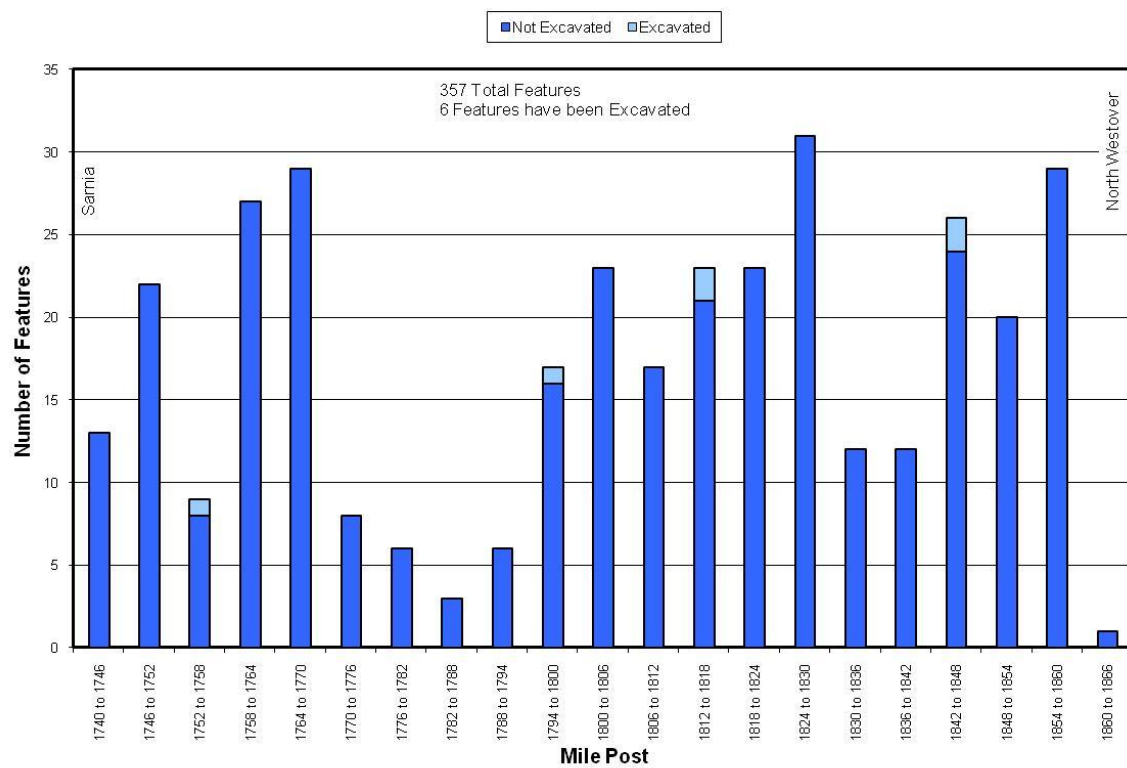
Figure 4.18 - Number of Features versus Chainage

The reported features are spread throughout the length of line between SA and NW; although the frequency of features varies along the length of the line there is no discernible trend (refer to Figure 4.18).

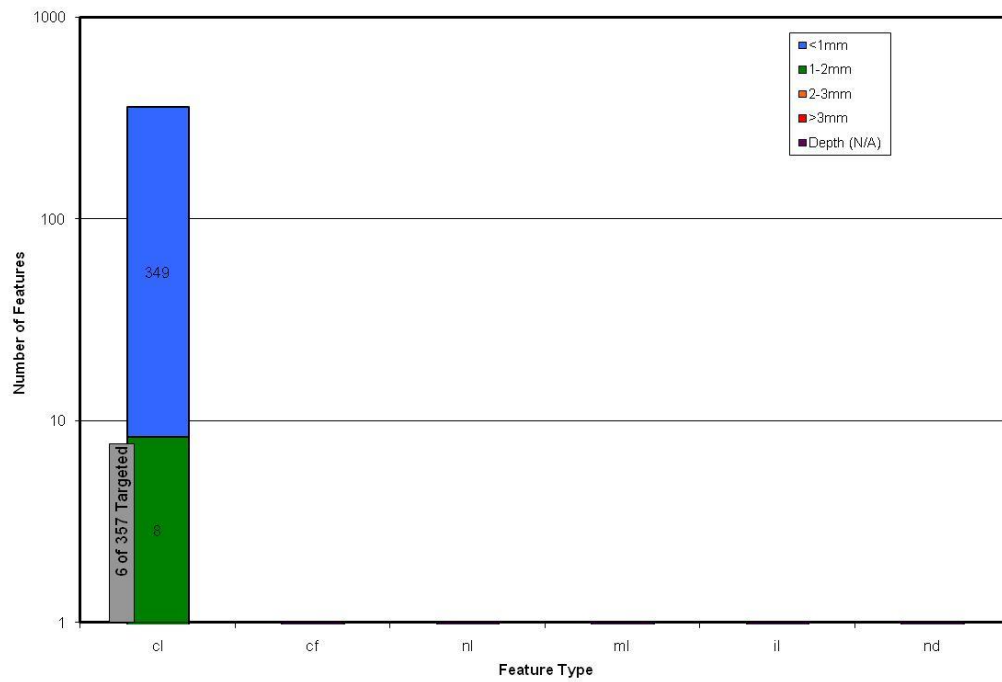
Figure 4.19 - Line 9 SA to NW Feature Depth Bins.

Approximately 98% (349) of the features had reported depths <1 mm while only 2% (8) features had reported depths between 1 and 2 mm (refer to Figure 4.19). There were no features with reported depths >2 mm.

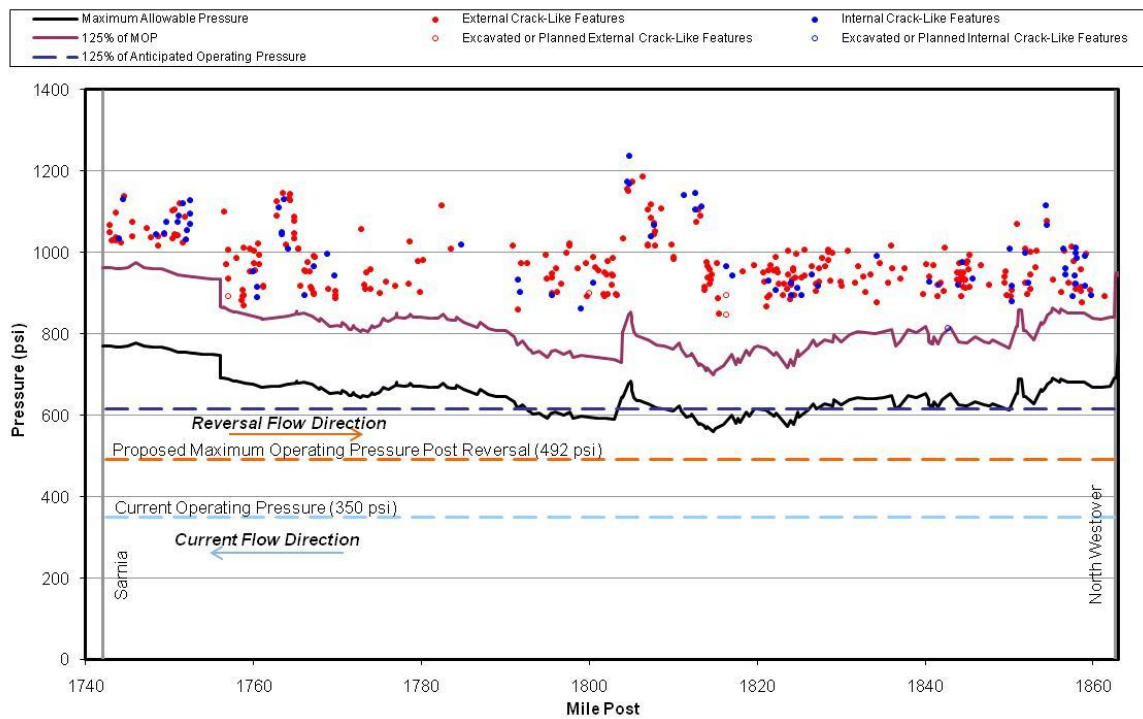
Figure 4.20 - Line 9 SA to NW Predicted Burst Pressures.

The lowest predicted burst pressure of the reported features, as determined using the CorLAS<sup>TM</sup> software, was 814 psi which equates to 125% of the MAOP and 165% of the proposed normal operating discharge pressure (492 psi) following the planned flow reversal (refer to Figure 4.20). This particular feature was excavated in 2009. The lowest predicted burst pressure of a reported feature, that hasn't yet been excavated nor is planned for excavation in 2011, is 870 psi which equates to 128% of the MAOP and 177% of the planned maximum discharge pressure (492 psi) following the planned flow reversal. As illustrated in Figure 4.21, there were no features with predicted burst pressures less than 125% of the MAOP while the vast majority (80%) of the features had a predicted burst pressure >140% of the MAOP. The following assumptions were used as input into the CorLAS<sup>TM</sup> software to calculate the predicted burst pressures of the reported features:
